UNITED STATES ENVIRONMENTAL PROTECTION AGENCY
REGION 5
77 WEST JACKSON BOULEVARD
CHICAGO, IL 60604

SUBJECT: INSPECTION REPORT – West Bay Exploration Co., Jackson County, Michigan

Facility: Haystead 1-9A (aka Norvell 9 CTB), Norvell Township

Date of Inspection: August 28, 2014

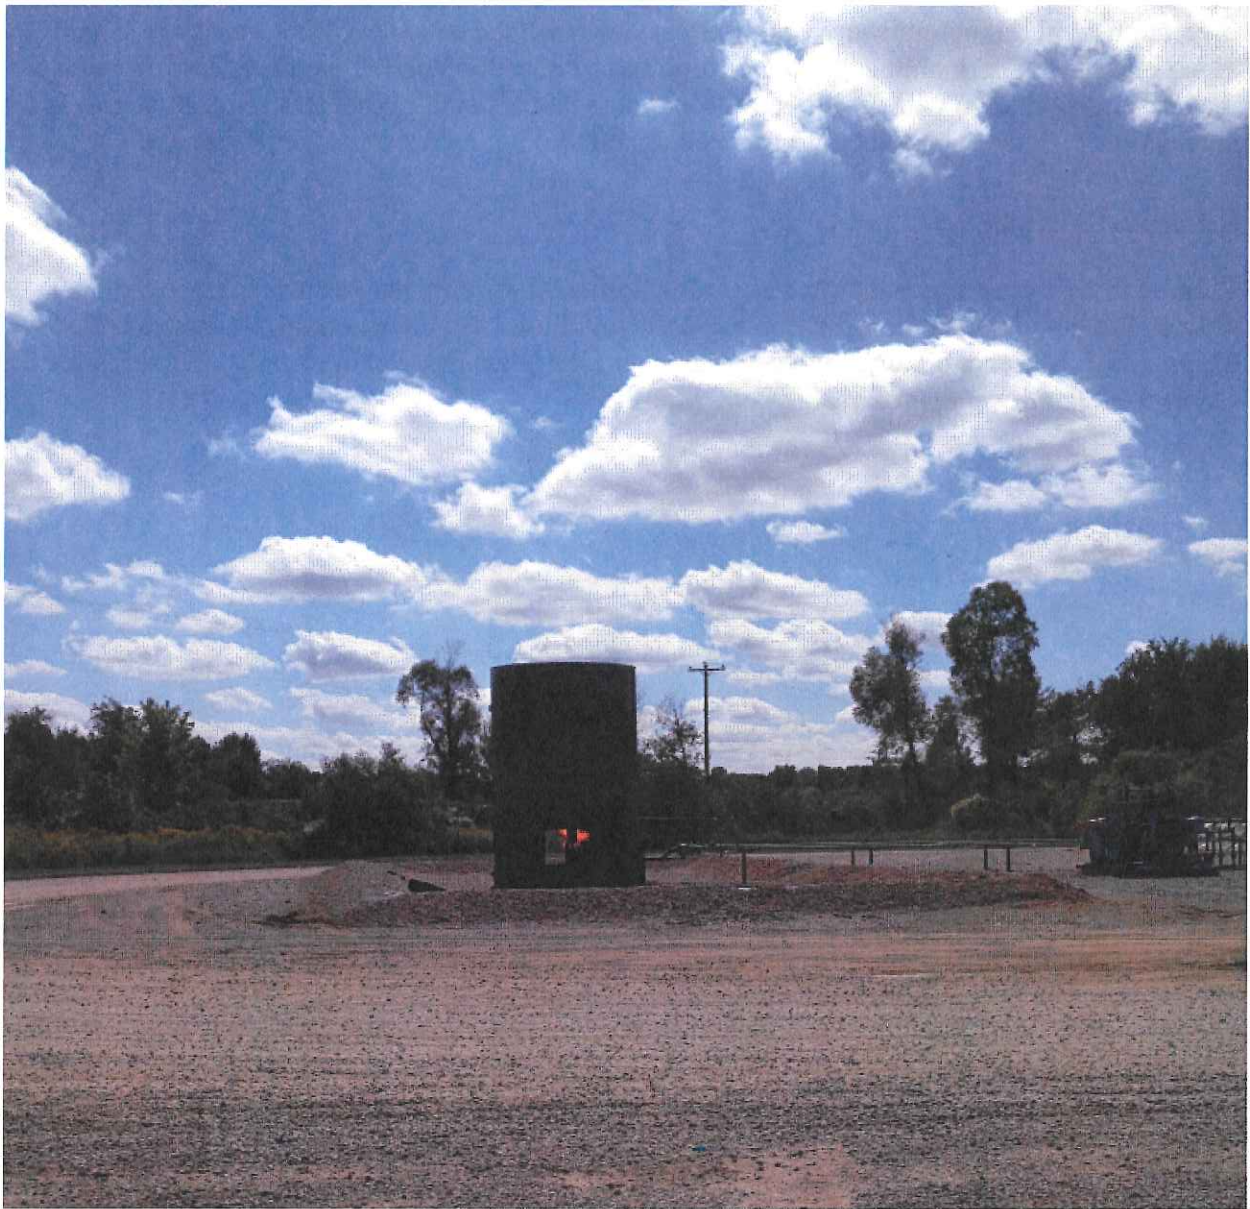
I also took an IR video clip of the flare. The flare was lit throughout the duration of the inspection and I did not note any visible emissions (with the naked eye) from the flare. The IR video clip shows a gas plume moving beyond the combustion zone of the flare. I briefly viewed the glycol dehydrators with the IR camera and noted a very small pinhole-sized leak at one of the connections, which I pointed out to Mr. Pelham but did not record with the IR camera.

1) Flare, lit.

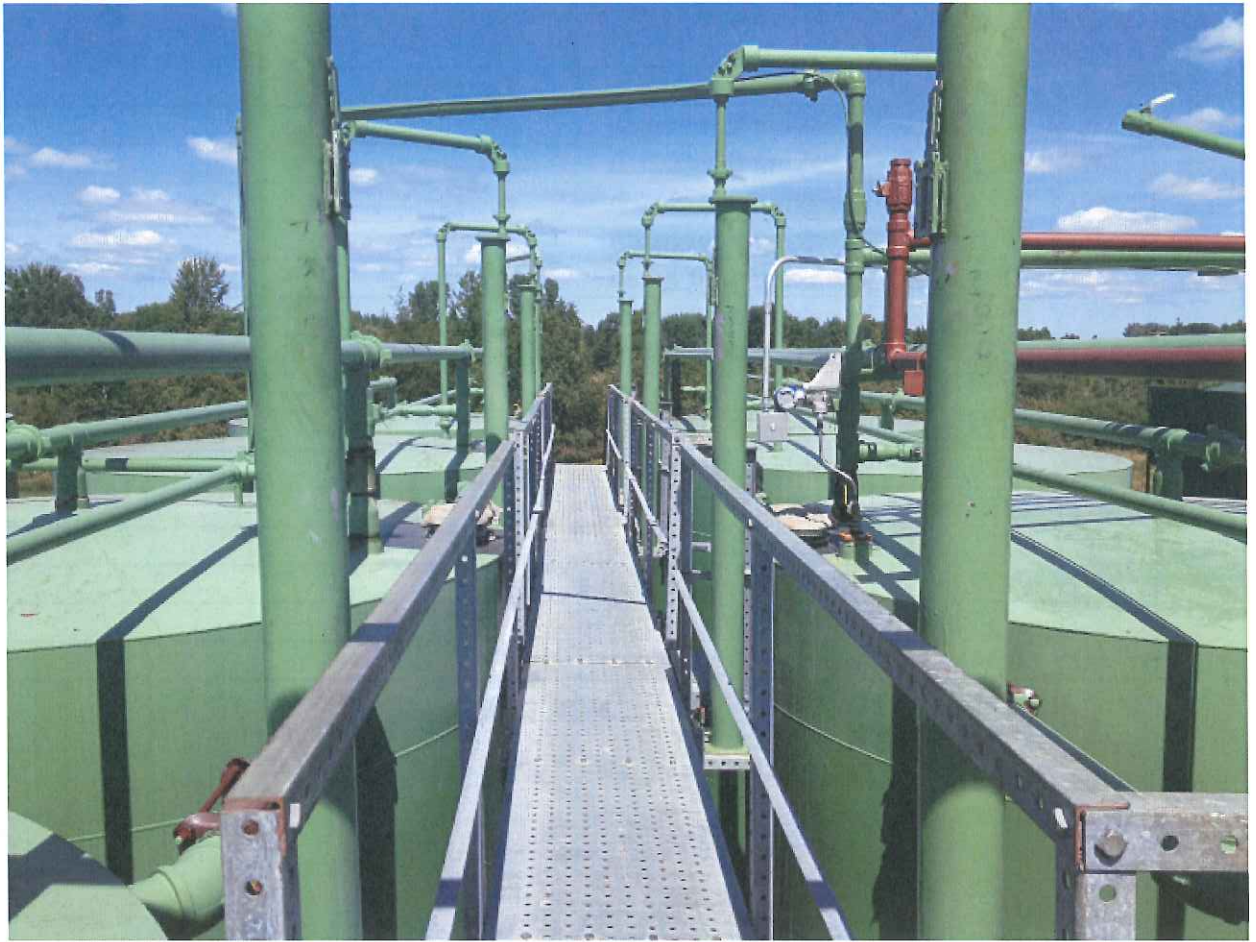
I began my tour at the tank battery. I made note of a petroleum-like odor at the facility, which was strong near the tanks. Upon climbing the stairs to the tops of the tanks, I used the IR camera (a FLIR GF320) to take video clips of leaking tank thief hatches. Hatches on seven of the eight oil/brine tanks currently in use were leaking, as well as hatches on seven of the eight tanks planned to be used for brine. In addition, the Enardo pressure relief valve was leaking continuously (see IR Camera Video log).

2) Top of tank battery.
